Final Report

Protecting electrical/electronic equipment from red imported fire ant damage

**Harlan Thorvilson and Bobby L. Green
Department of Plant and Soil Science
and
Department of Engineering Technology
Texas Tech University**

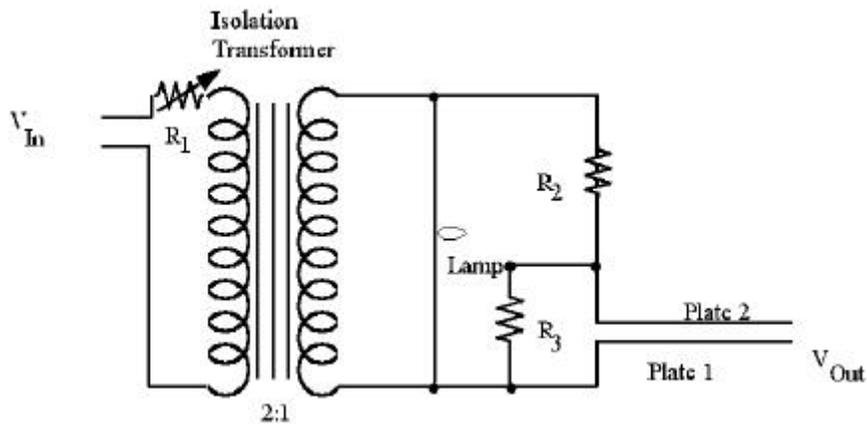
Figure 2.1 Electrical Schematic of 208-V Field Device 1

As can be seen from the figure the SED was an elaborate device to deploy in a hostile environment in the field. As the number of parts on the device increases the probability of device failure also increases. The materials cost for this device was high, the energy cost for this device was also large, and the device was too bulky and complex for a field unit.

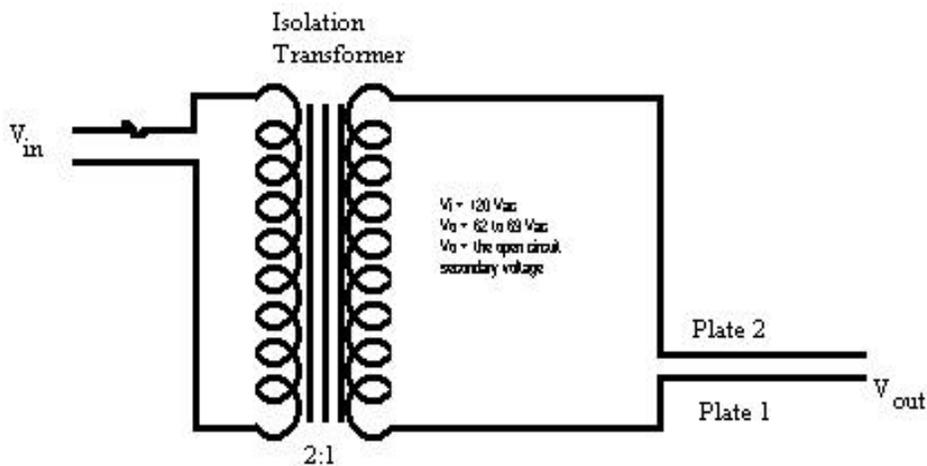
Figure 2.2 Electrical Schematic of 120-V Field Devices 2 and 3

The second device deployed in the field used a fused 120-Vac to 60-Vac step down transformer with a current limiting resistor. The lower voltage transformer was less bulky and less expensive than the 208-V transformer and when energized used less than half the power of the 208-V device. The transformer could be used with the 120-V phase-to-ground connection in the pad-mounted transformer. The electrical schematic in figure 2.2 shows the reduced complexity of the design. The secondary was an open circuit operating at around 60-Vac so the power consuming voltage divider network and indicator lamp had been removed. Reducing the complexity of the device made it more reliable in the field, however it was still bulky, heavy and was the transformer was a power-consuming device. The device operated relatively well in the field for a prototype device and gave us the opportunity to determine ant behavior in the field when confronted with the SED. The ant behavior was to attempt to defeat the device. Super colonies could defeat the device by covering the device completely with earth. Because the device was a single stage device covering the single stage would short the output of the device and allow the current limiting resistor to overheat and fail. When confronted by a small colony the device would often the colony before it was covered with earth.

After discovering the behavior we modified the device from a single stage device to a double stage device. Having two independent circuits operated from the same transformer allowed for defeat of a single stage while leaving one stage in tact and operational. In order to defeat the

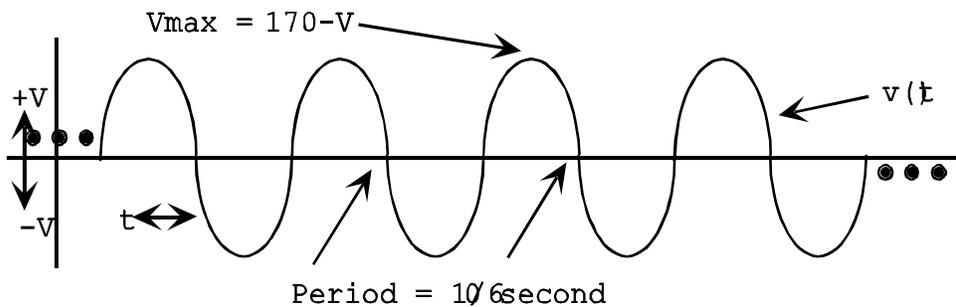
Figure 2.3 A 60-Hz, 120Vac RMS Voltage Signal

and is shown below in figure 2.3. The diodes act as a current check valve or gate.

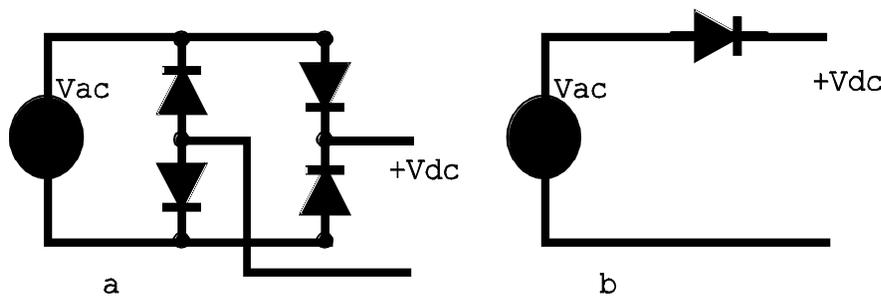
Figure 2.4 a) Full wave rectifier and b) Half wave rectifier networks

They show a very high resistance to reverse current and very low resistance to forward current. The diode may be connected in several ways for rectification of a voltage signal. For single-phase full wave rectification usually 4 diodes are used in a bridge network and single-phase half wave rectification may be accomplished using only one diode as shown in figure 2.4

The two rectifiers are shown with the output as an open circuit, a "no load" configuration. In the no load configuration no current flows through the network so no power is consumed in the no load configuration. Power will be consumed only when a load appears across the output of the rectifier and the power consumed is proportional to the resistance of the load.

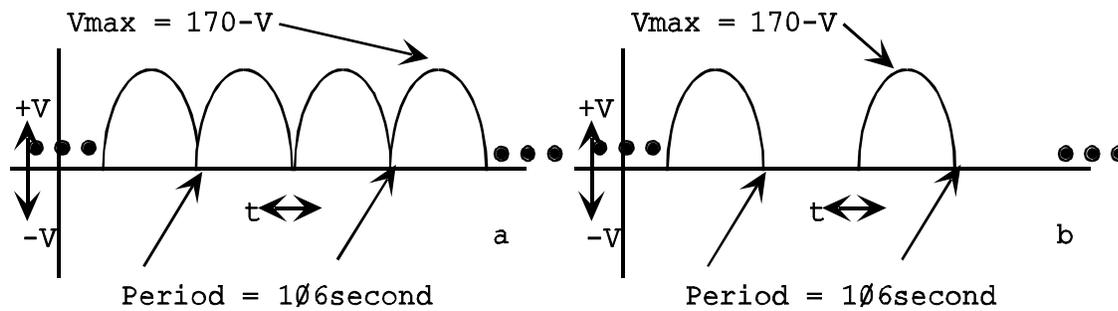
Figure 2.5 a) Full wave rectification and b) Half wave rectification

The voltage signals resulting from the full wave and half wave rectification networks are shown in figure 2.5.

The diodes change the voltage signal from a positive and negative alternating voltage signal to a pulsating positive signal. Full wave rectification saves the entire voltage wave from the sinusoidal signal, while half wave rectification saves only half of the voltage signal.

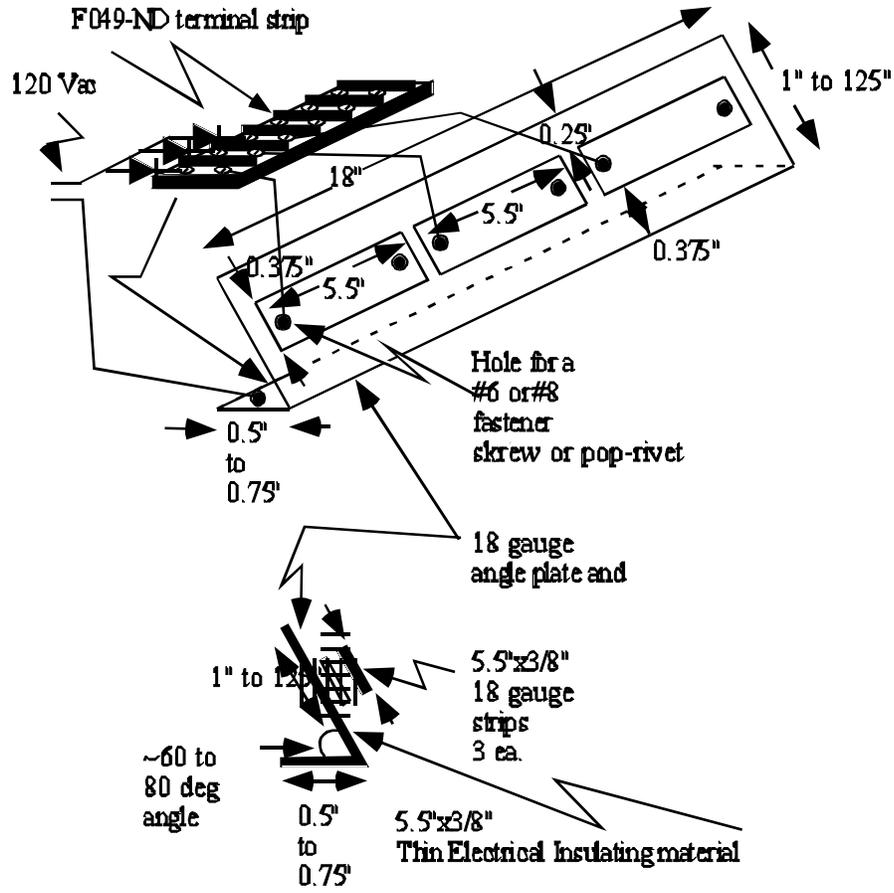
Figure 2.6 A three stage SED

The expected failure mode was burial of the device so the device was designed as a three-stage device or three half-wave rectifiers per device using a single fuse. As the ants cover a stage a large current would be drawn through the diode. As each diode was drawn into a high current mode of operation the diode would over heat and fail leaving the remaining stages in tact and operational. In a catastrophic failure a mode very low resistance short circuit would draw a very high current and activate a fuse to prevent transformer damage. A drawing and simplified schematic of the device is shown in figure 2.6.

In figure 2.6 it can be seen that the device is made in three sections. The device conducting material is stainless steel with three small rectangular energized conducting plates separated from the larger grounded substrate by a thin piece of electrical insulation material. Stainless steel conductors were 18 gauge 304 or 316 SS with a 4 to 6 mil plastic insulating material between the two conductors. The energized plate was fixed to the ground plate with non-conducting nylon screws. A terminal strip was installed for all the necessary electrical connections. A fused conductor was connected between a 120-Vac terminal inside the residential transformer and the terminal strip with the fuse as close to the transformer terminal as possible. The fuse is to provide electrical protection for the power transformer. In the event of a short circuit from a 120-Vac terminal to ground inside the transformer a small conductor would go to its maximum current carrying capacity. The intense current surge would rapidly heat the conductor to the melting point of the conducting material. The small conductor can explode and ignite any combustible material in the transformer. Power wires, ground wires, diodes, the three energized plates, and the ground plate were attached to the terminal strip.

We did not view a resistor in the output of the device as a necessary element because the ants were going to be the resistive load and a resistor might limit the effectiveness of the output of the device. The device was assumed to have a graceful failure mode. If there is enough moisture in the ground, as the ants buried the device shorting it between an energized plate and the ground plate, the diodes will begin to conduct. If the earth is a large enough conducting load the diode would over heat, open circuit, and fail while the fuse would pass the load until diode failure. The

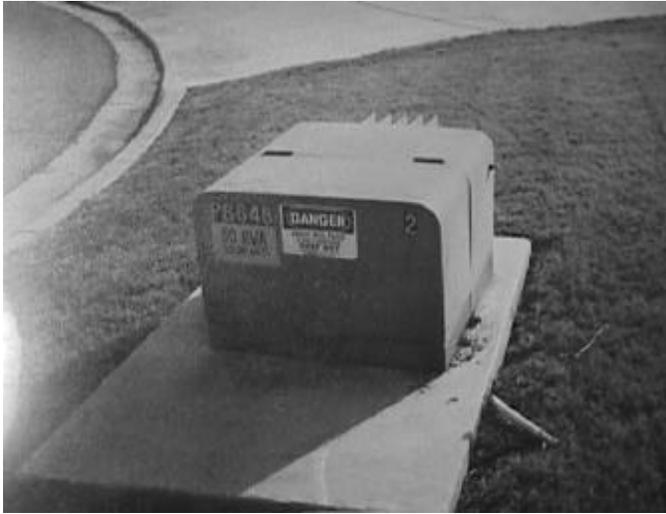
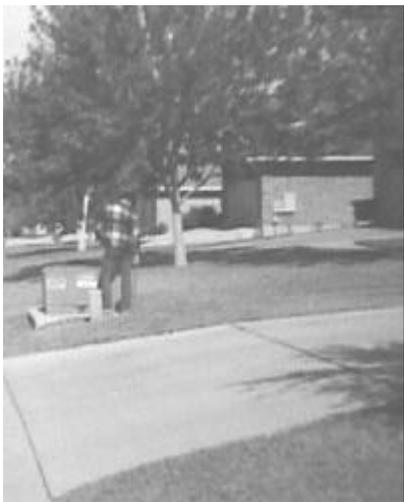
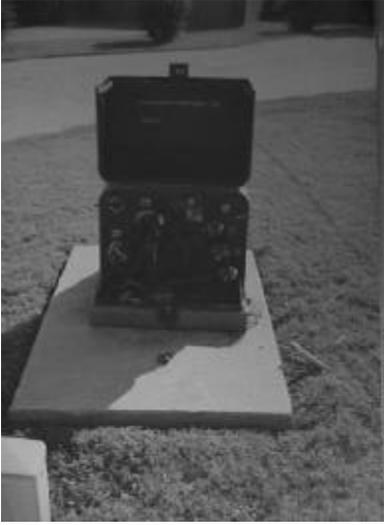
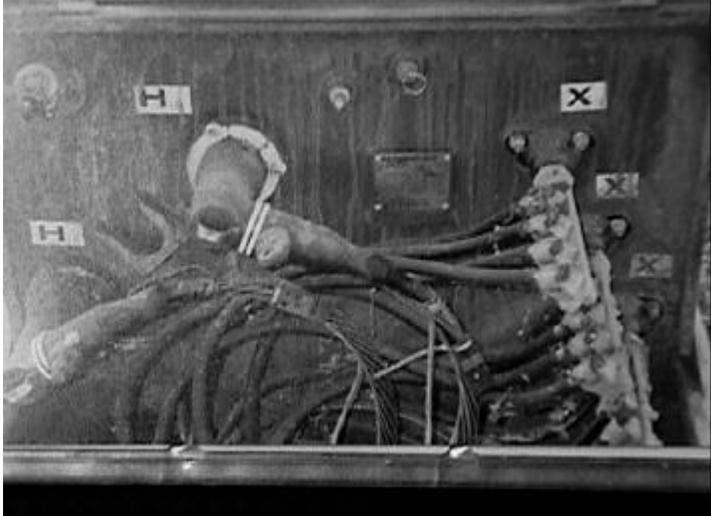
Figure 2.7 Pad Mounted Residential Transformer Internal Wiring

The high voltage connections are well insulated and the low voltage and ground connections are sometimes left bare for ease of residential connection.

Installing the ant device among these conductors is a difficult task. The device is the shape of a 45-cm steel bar so cleaning out an old ant mound and manipulating the device around all the conductors and advantageously positioning it is tedious and time consuming. Many times the device will be gouged into the soil, or tipped onto the active surface after installation, or poorly positioned in the transformer. After the device is positioned and energized it is sometimes necessary to reposition the device. The linemen often repositioned the device while it was energized. It is not an unsafe procedure, the linemen are well protected and the device is operated at a very low voltage as far as electrical power voltages are concerned. If the device is unintentionally grounded during the manipulation a high current short circuit is introduced onto the device, the fuse and several of the diodes are usually destroyed. The fuse protects the pad mounted transformer from any wire melting from the device power conductor but the high current pulse through the fuse and a diode, due to the short, usually cause voltage and current reflections that damage one or both of the remaining diodes. In the confined space and uneven surfaces the devices would be repositioned several until a satisfactory position was accepted. The concern with positioning the device was due to the several different internal designs of pad mounted transformers encountered in the field. The conductor congestion in the transformers was also variable. Several residences served by a single transformer meant several sets of residential conductors in the transformers. Few residences served meant few conductors.

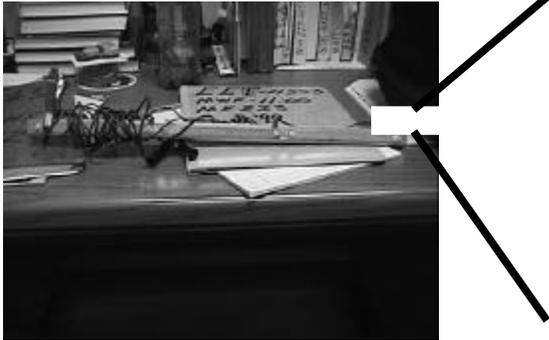
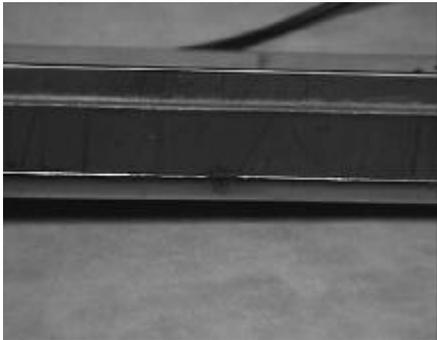
Figure 2.8 Typical Field Device Short Circuit Arc Failure

During device field installation about one device in 15 would fail. The failure mode was a high-current arc from the energized plate to the ground plate when the device was energized. Figure 2.8 shows a typical device short circuit arc failure.

The second failure mode, a short-circuit failure, was a catastrophic failure and was later determined to be a design defect. The active portion of the device was designed in three layers, conductor, insulator, and conductor. The conductors were 18-gauge stainless steel conductors, and the insulator was a 4-mil to 6-mil flexible plastic insulating material. The stainless steel and plastic were chosen for long-term corrosion resistance. During the initial design and testing the device was not found defective. The device was tested in Waco, TX and Lubbock, TX. The test devices were probably more carefully prepared than the prototype production devices. After initial test the devices were installed in several locations around the Dallas-Fort Worth area. A few of the devices spontaneously failed during installation and the failure was attributed to poor craftsmanship in those cases. On the return inspection trip after device installation, we discovered many of the devices had spontaneously failed in place with little or no activity. A forensic study was conducted on the devices returned from the field to determine the cause for the catastrophic failure mode.

An arc failure in the field indicated an unanticipated design flaw in the device. During manufacture the stainless steel was cut with a mechanical shearing device. The shear is a large pair of scissors with two cutting edges, one fixed and one movable. As the movable shear cuts any sheet metal the metal is deformed as it is cut leaving a smooth edge and a jagged edge on the sheared metal. The shearing operation also leaves metal fibers attached to the sheared surfaces. It is a standard procedure to cut thin sheet metal with these shearing machines in the manufacture of mechanical devices. In the manufacture of electrical devices the jagged edges and metal fibers are very bad. The jagged edges cause electric field enhancement regions between conductors. Whereas a pair of conductors may be separated by several kilovolts of air insulation, a sharp edge will enhance the electrical field in the region near the edge causing an electrical corona to form. The corona is an ionized gas plasma and the plasma forms a very good conductor near the sharp edge. The insulating qualities of the non-ionized air is still 30-kV/cm; however, the insulating qualities of the ionized air is about 0.0-kV/cm, or a short circuit. During design of the SED, the jagged edge problem was recognized and the metal was to be sheared in a manner to reduce the

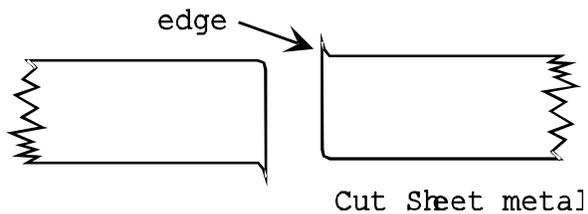
Figure 2.9 Sheared Sheet Metal with Edge

field enhancements or eliminate them completely. Figure 2.9 illustrates the jagged edge associated with shearing sheet metal.

The shearing process always leaves the jagged sheared edge, but the sheet metal may be manipulated to produce the edge on the same plane surface. If the cut sheet metal is placed with the jagged edges facing each other (Figure 2.10a), the distance between conductors is reduced and each edge can generate an electric field enhancement region causing ionization and arcing. The sheet metal is shown with only one edge (Figure 2.10b). The field enhancements at the sharp edge are still large, but only one enhancement region exists, and the separation distance between conductors is increased improving the insulating qualities of the air. The edges are facing away from each other (Figure 2.10c), and smooth rounded surfaces are facing each other. The smooth rounded surfaces reduce field enhancements and reduce the risk of an arc discharge.

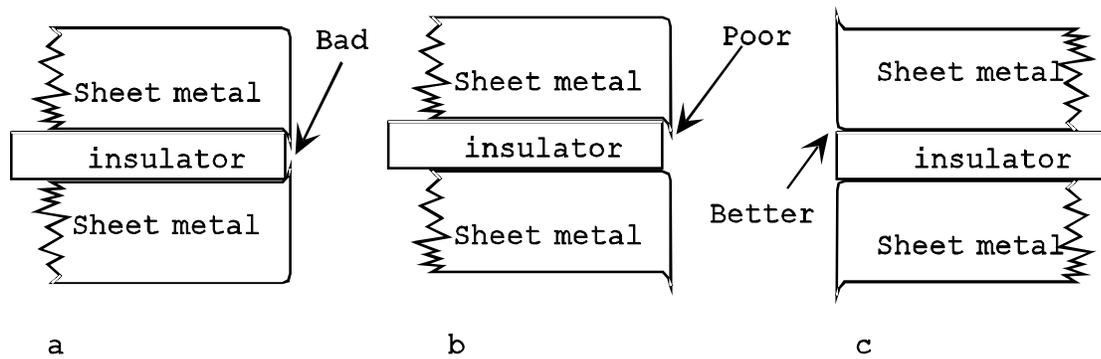
Figure 2.10a) Facing Edges b) Single Facing Edge c) No Facing Edges

The jagged edges can either be ground off or the edge may be faced away from the ground plane. We chose to leave the edge and face the edge away from the ground plane. The solution worked well, and device manufacturing continued. Some of the arcing failures experienced in the field was due to metal shavings and debris near the edge of the conductor-ground boundary as shown in (Figure 2.11).

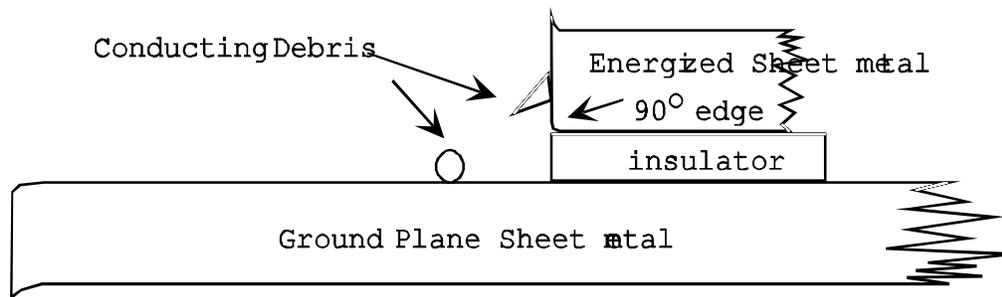
Figure 2.11 Conducting Debris Near Device Conductors

The conducting debris reduces the insulating separation distance of the air or, in the case of a sharp edged piece of material, will cause field enhancements and arcing. The stray sharp pieces can result as a residue from the sheet metal cutting operation. Also a dirty contaminated area may introduce stray conducting material in or around the active region of the device.

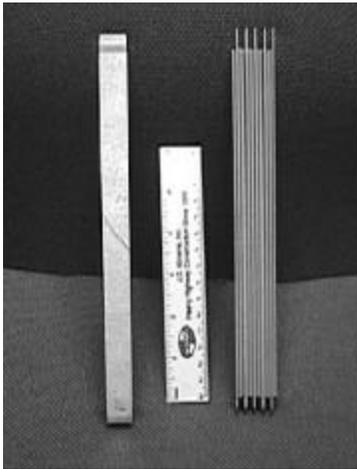
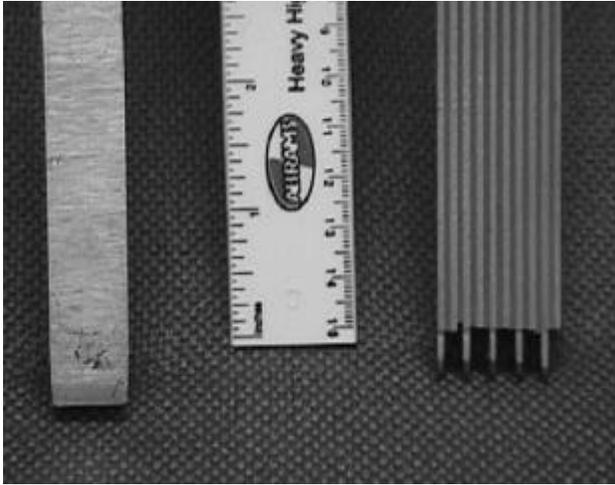
Figure 2.12 Stainless Steel Sandwich

The first redesign was a sandwich of stainless steel and plastic insulator (Figure 2.12), and Figure 2.13 shows the construction of the sandwich. The insulator and the stainless steel are both 18-gauge materials sandwiched together with an adhesive material. Materials were purchased in standard industrial sheets then cut into 20-cm x 30-cm sheets. Sheets were then bonded in an insulator-stainless steel sandwich with 10 layers of stainless steel and 9 layers of insulator. The sandwich was about 2.5-cm thick with five independent, active sections. The 20-cm x 30-cm sheets were then cut into 20-cm x 1.5-cm x 2.5-cm strips using a supersonic water jet cutter. Cuts were made with the jet cutter to prevent metal contamination and produce a vertical edge with a very smooth surface. The insulating material has a breakdown strength of about 500-kV/cm. After design and construction of a few of the sandwich devices, they were found to be very strong, tough, and fail-safe. The new construction increased the working surface by a factor

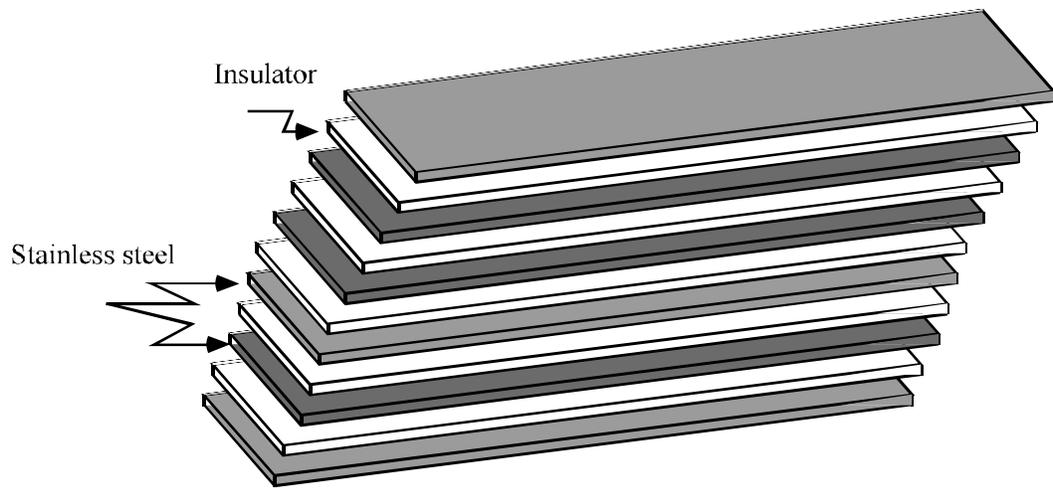
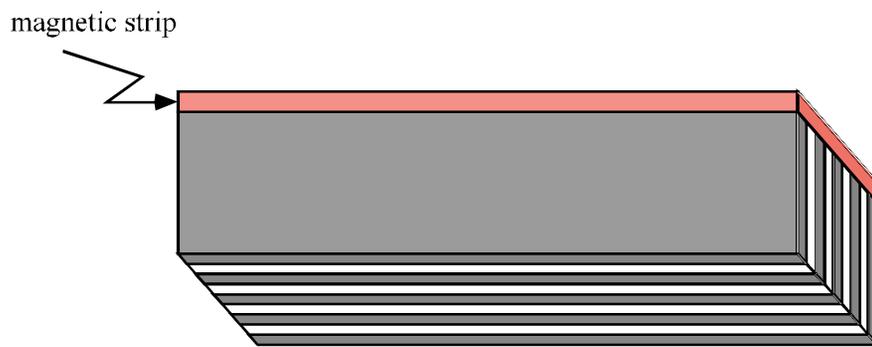
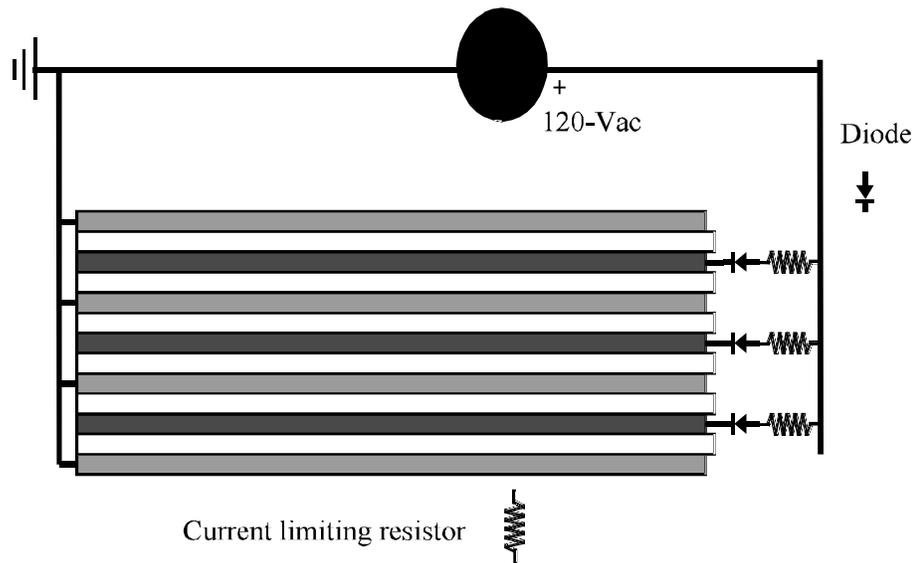
Figure 2.13 Sandwich Construction

of four. The reduced length of the devices would make them simpler to install, and the rectangular foot print and weight of the device made it very stable; however, being only 2.5-cm tall an aggressive colony of ants could cover the new device with soil. Devices were very expensive to construct, and bonding electrical conductors to stainless steel is difficult. The cutting operation was very clean , left a very nice edge, but was expensive, and the device was limited in height by the limitations of cutting tool. The cost of the stainless steel sandwich was too great to be acceptable for a several hundred devices.
